PLAN 2

PERIOD 1999

Expert advice report

Alleged Right of Way (RoW) issue

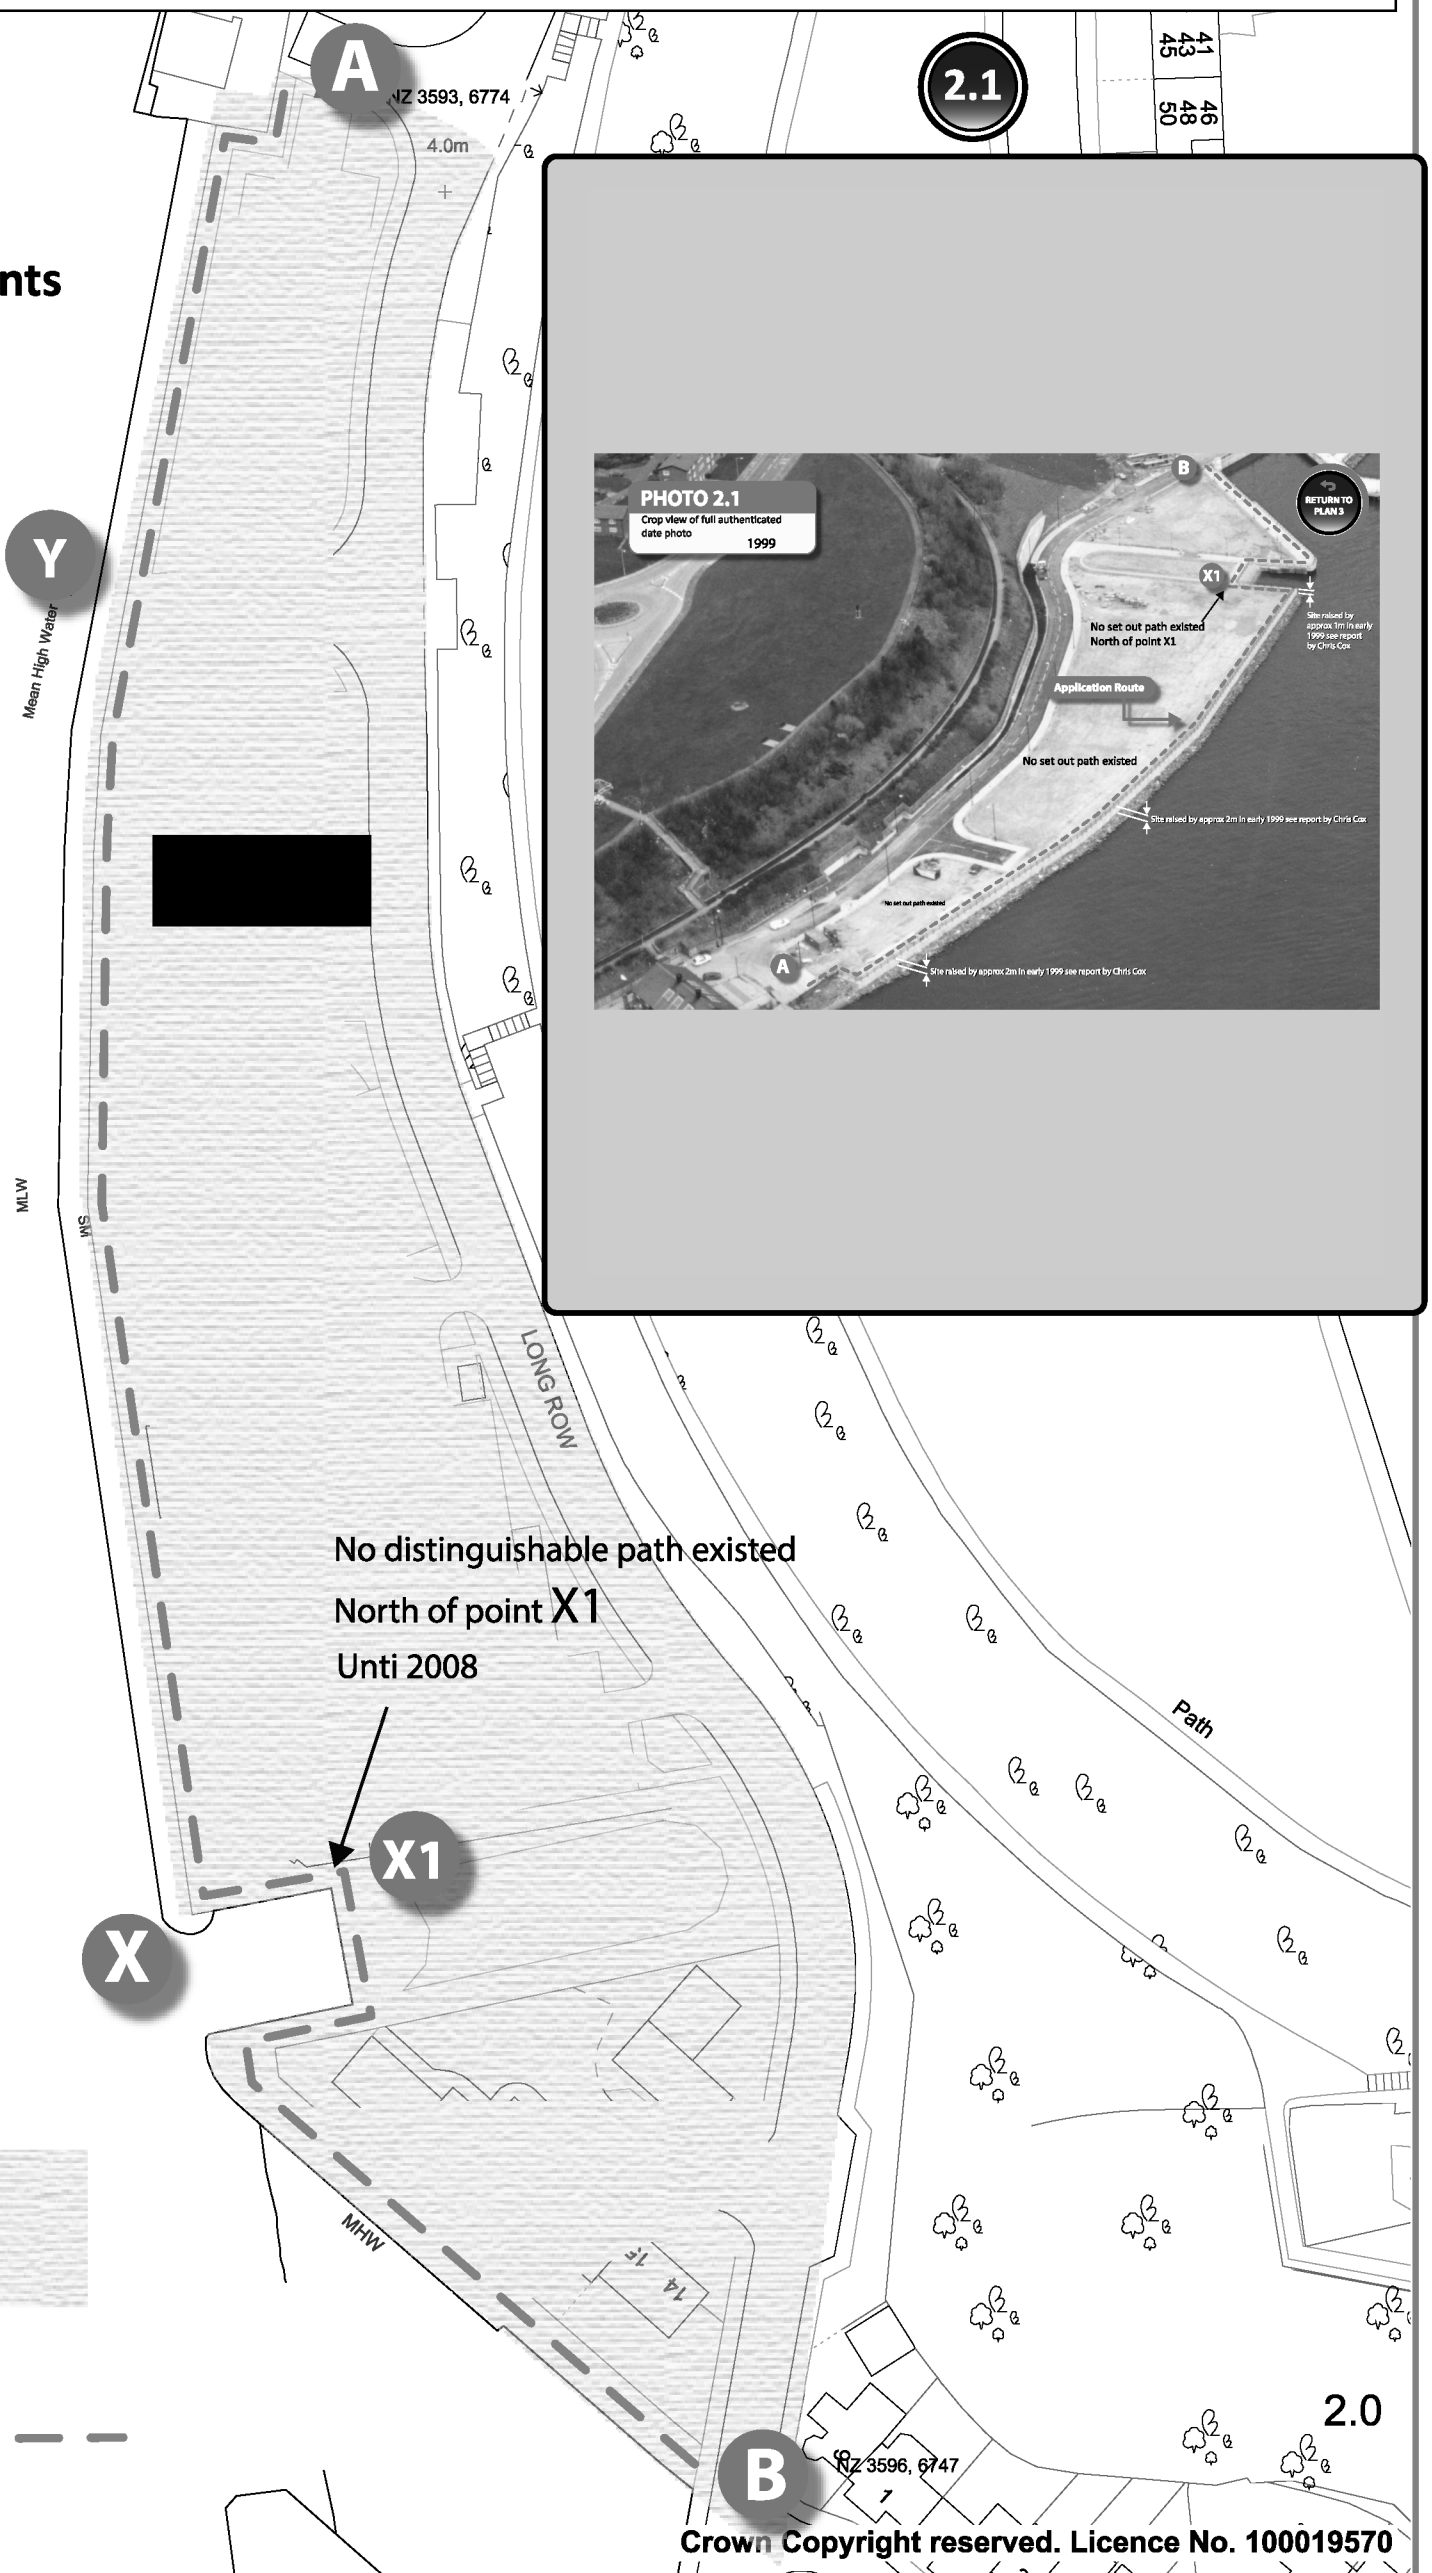
PHOTO 2.1

Crop view of full authenticated
date photo T009-13 **1999**

No set out path existed
North of point X1

Site raised by
approx 1m in early
1999 see report
by [REDACTED]

Site raised by approx 2m in early 1999 see report by [REDACTED]

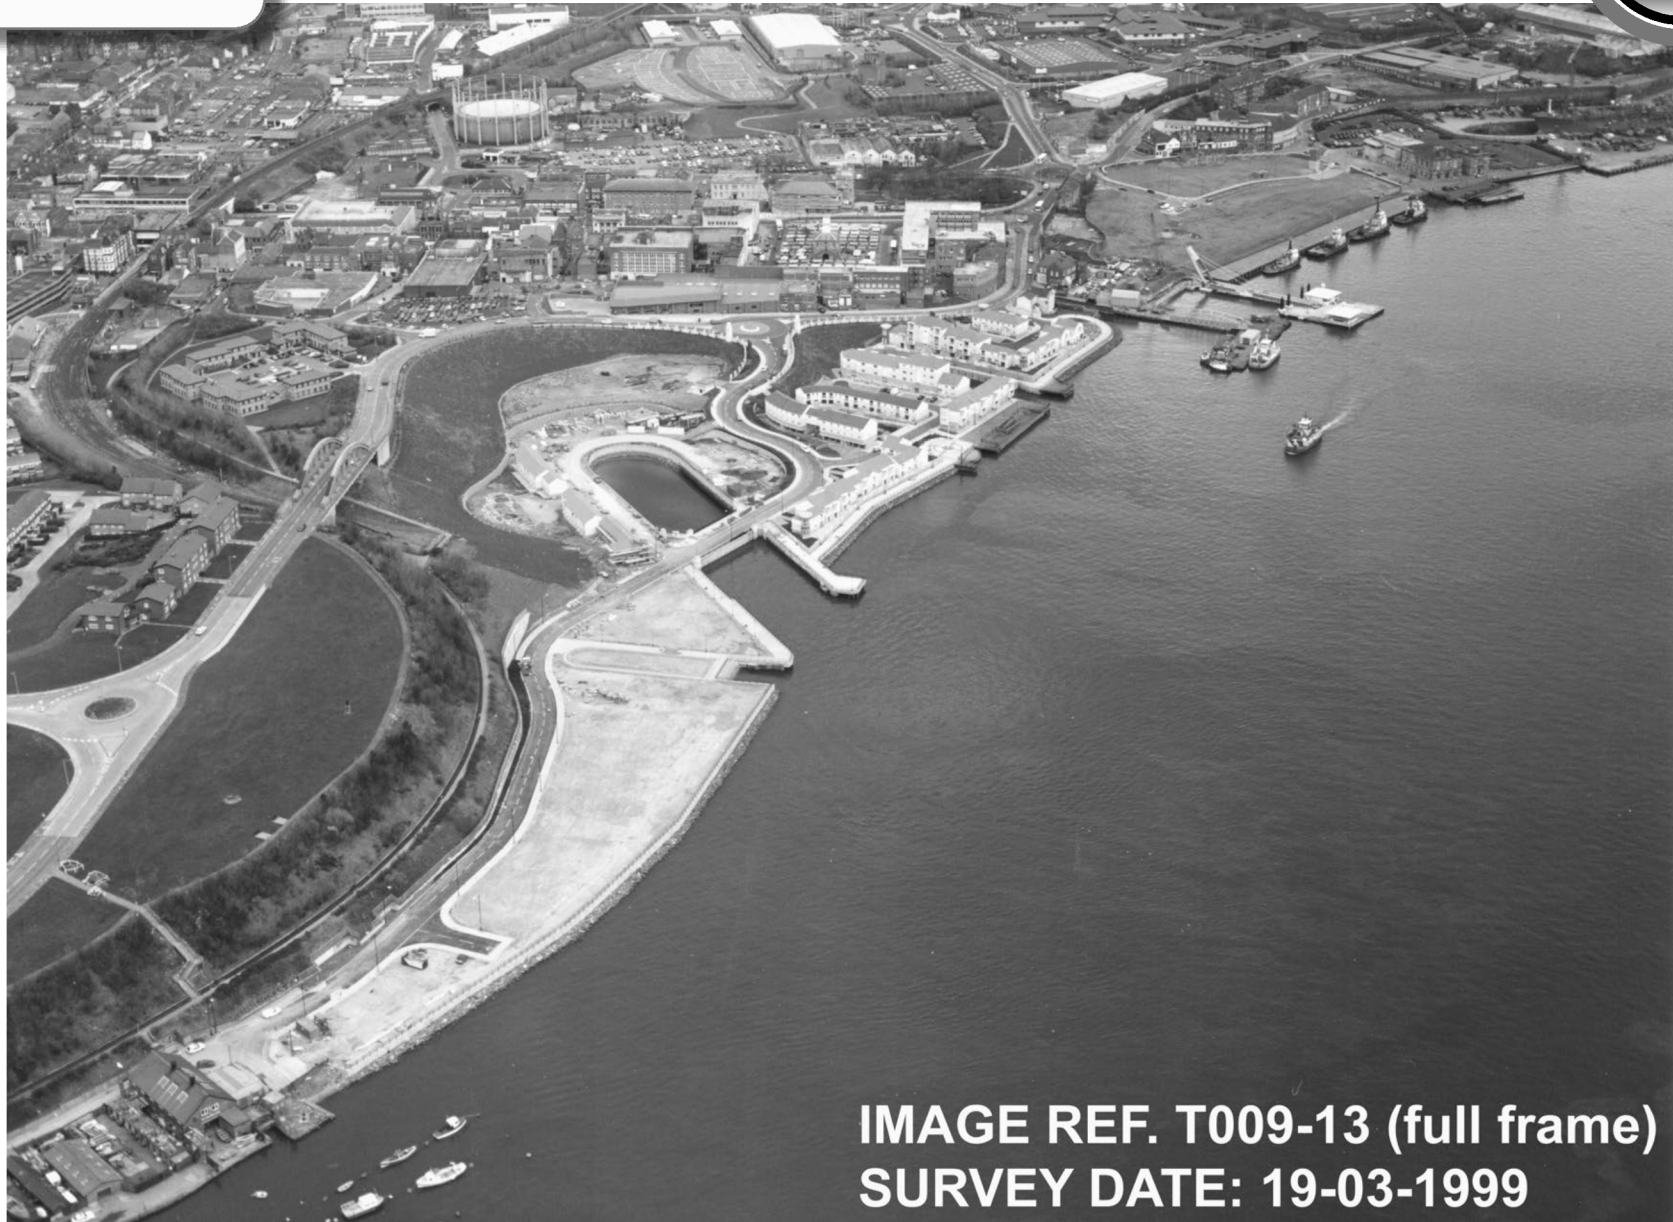
PHOTO 2.2

**IMAGE REF. T009-13 (full frame)
SURVEY DATE: 19-03-1999**

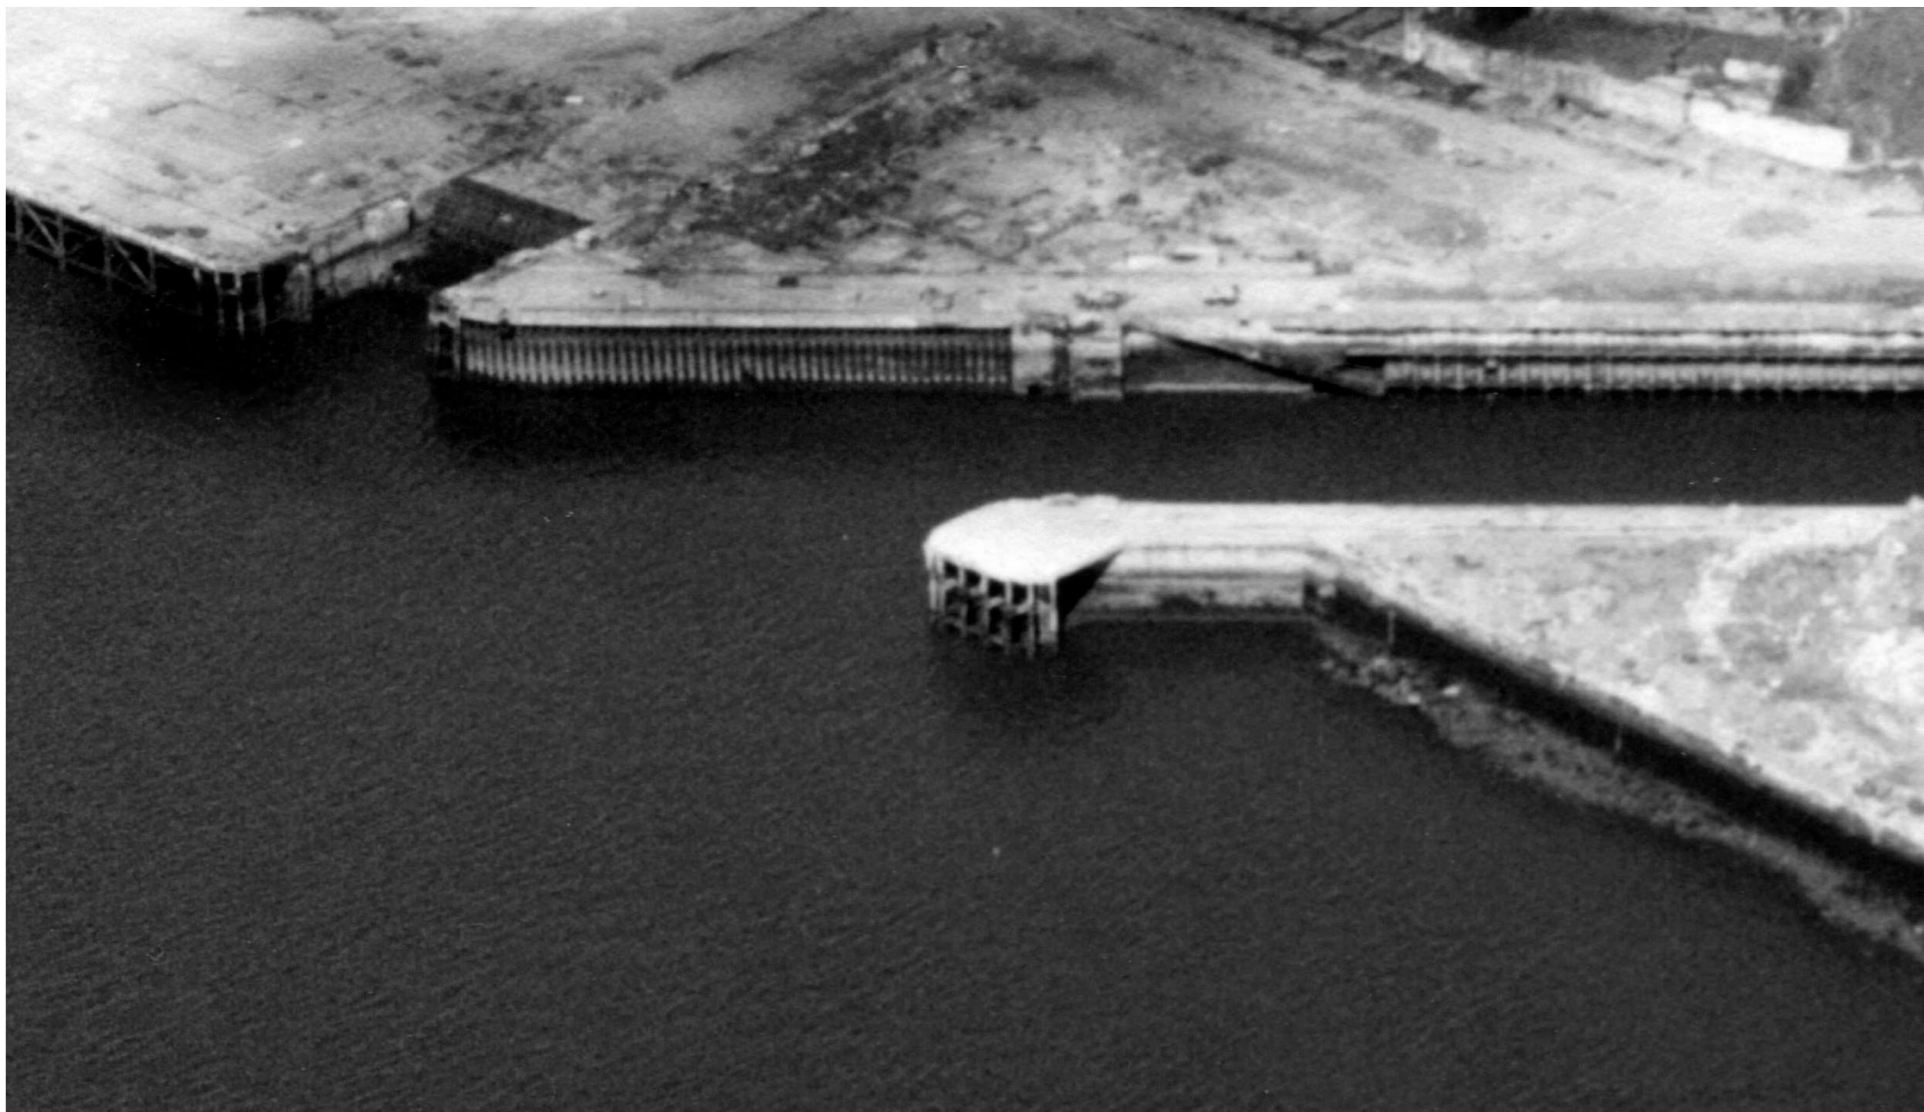
Item 1: 1996 Enlargement to show details of the original site level prior to raising

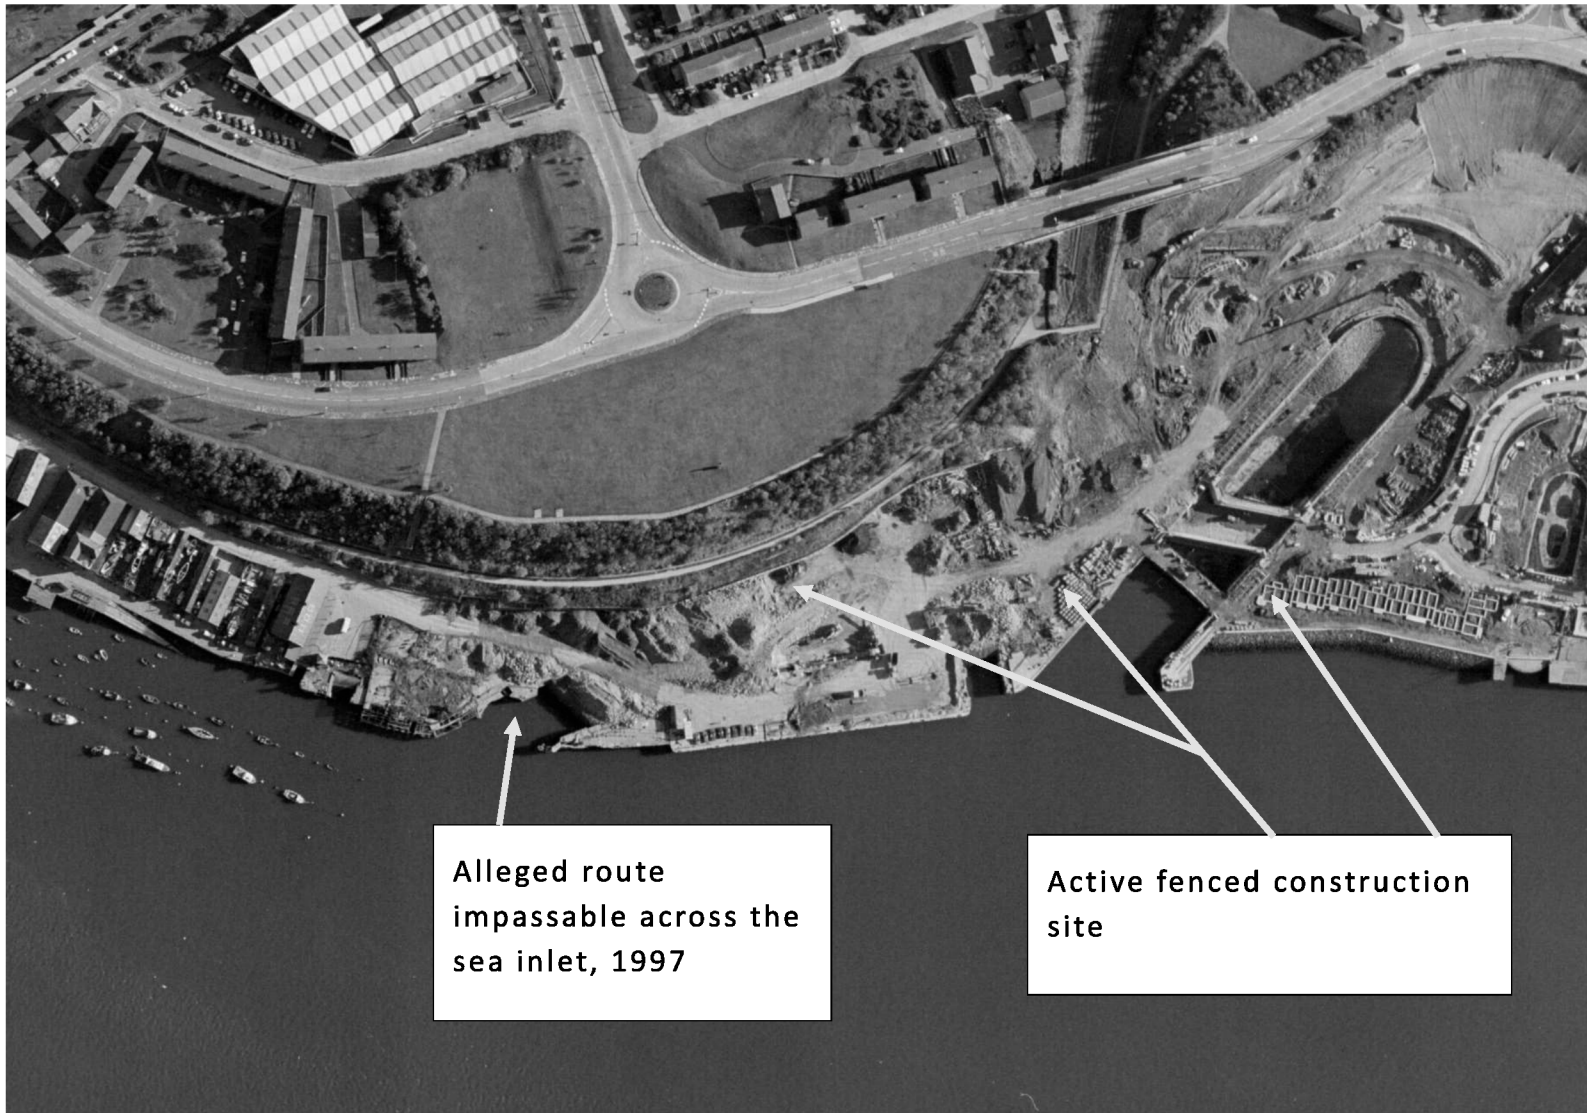
Item 2: Sea inlet present which is traversed by the alleged route where it is impassable across the water, and active fenced groundworks over the site

Alleged route
impassable across the
sea inlet, 1997

Active fenced construction
site

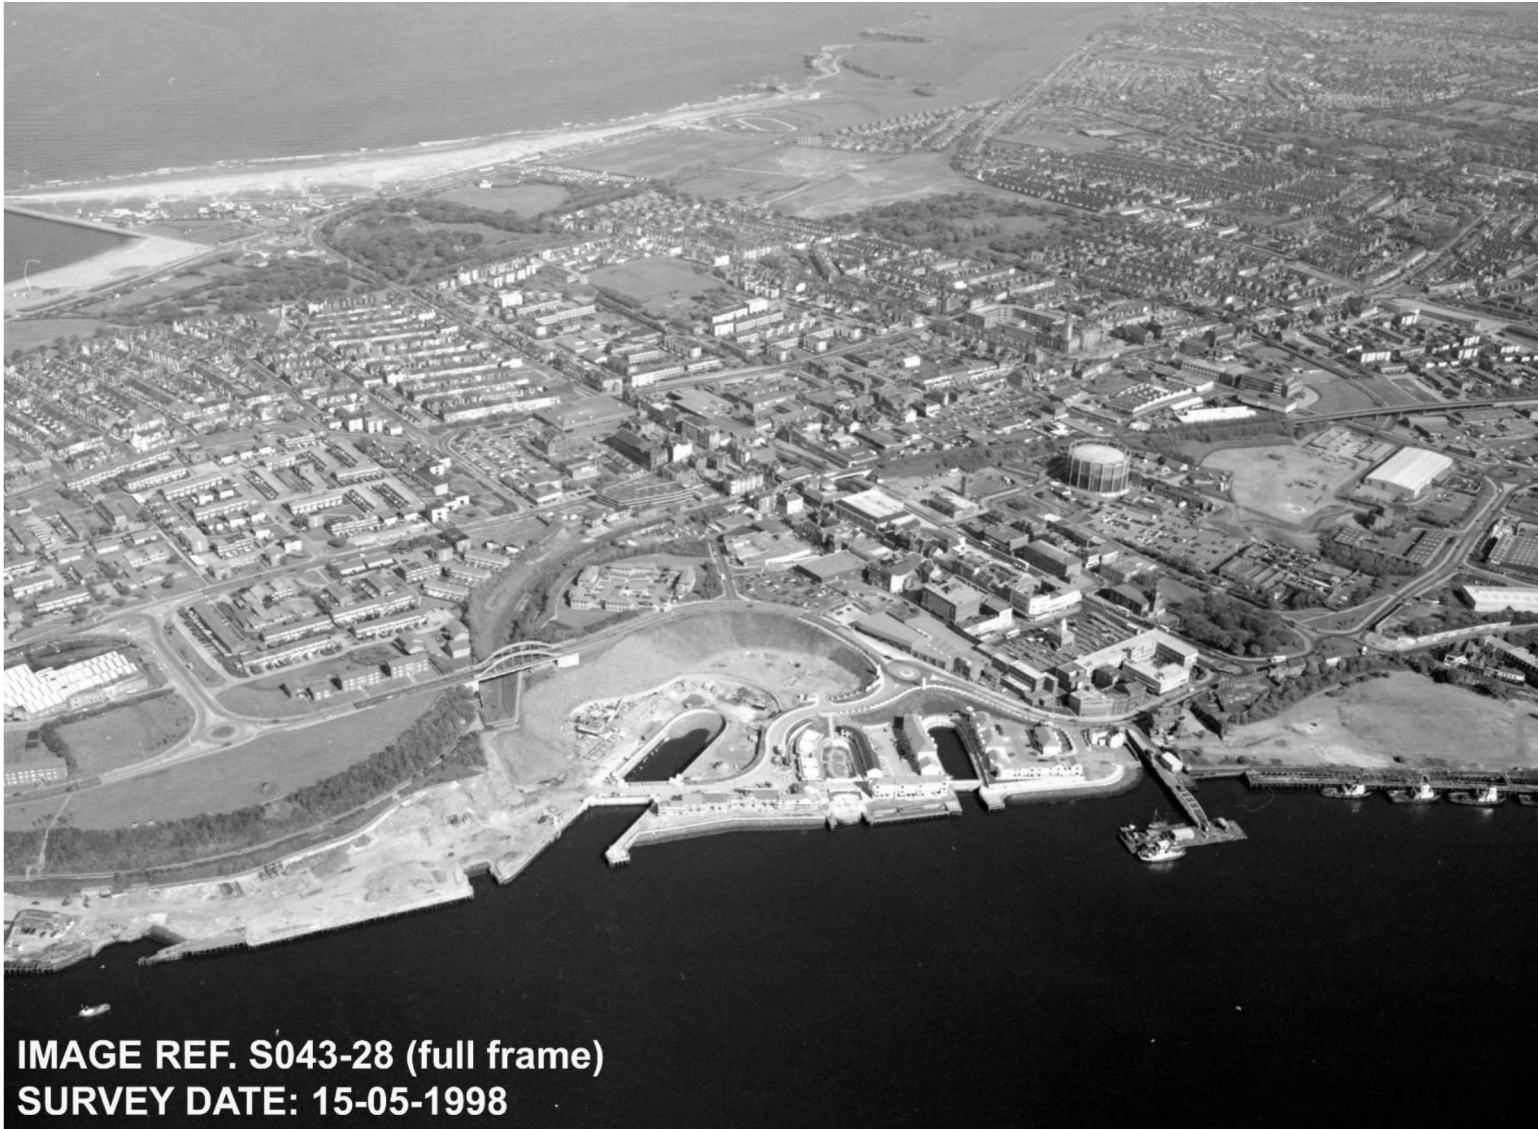
Item 3: 1998, construction in progress, sea inlet present

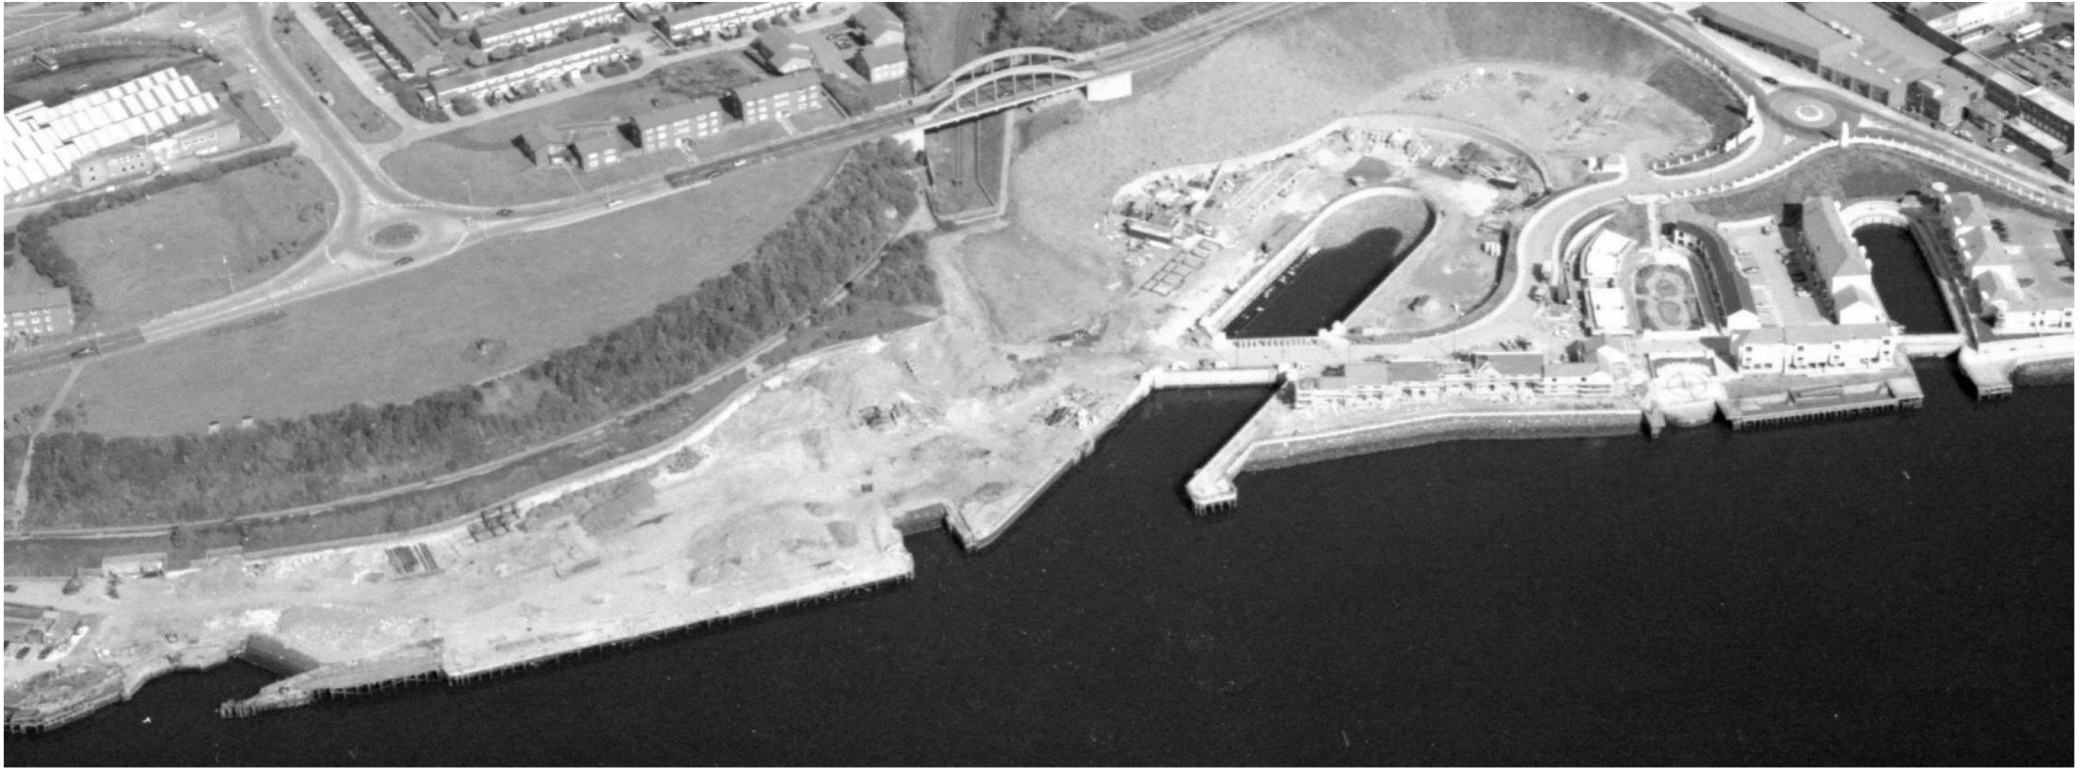
Item 3: 1998 enlargement: Sea inlet present, site under releveling, construction and fenced groundworks

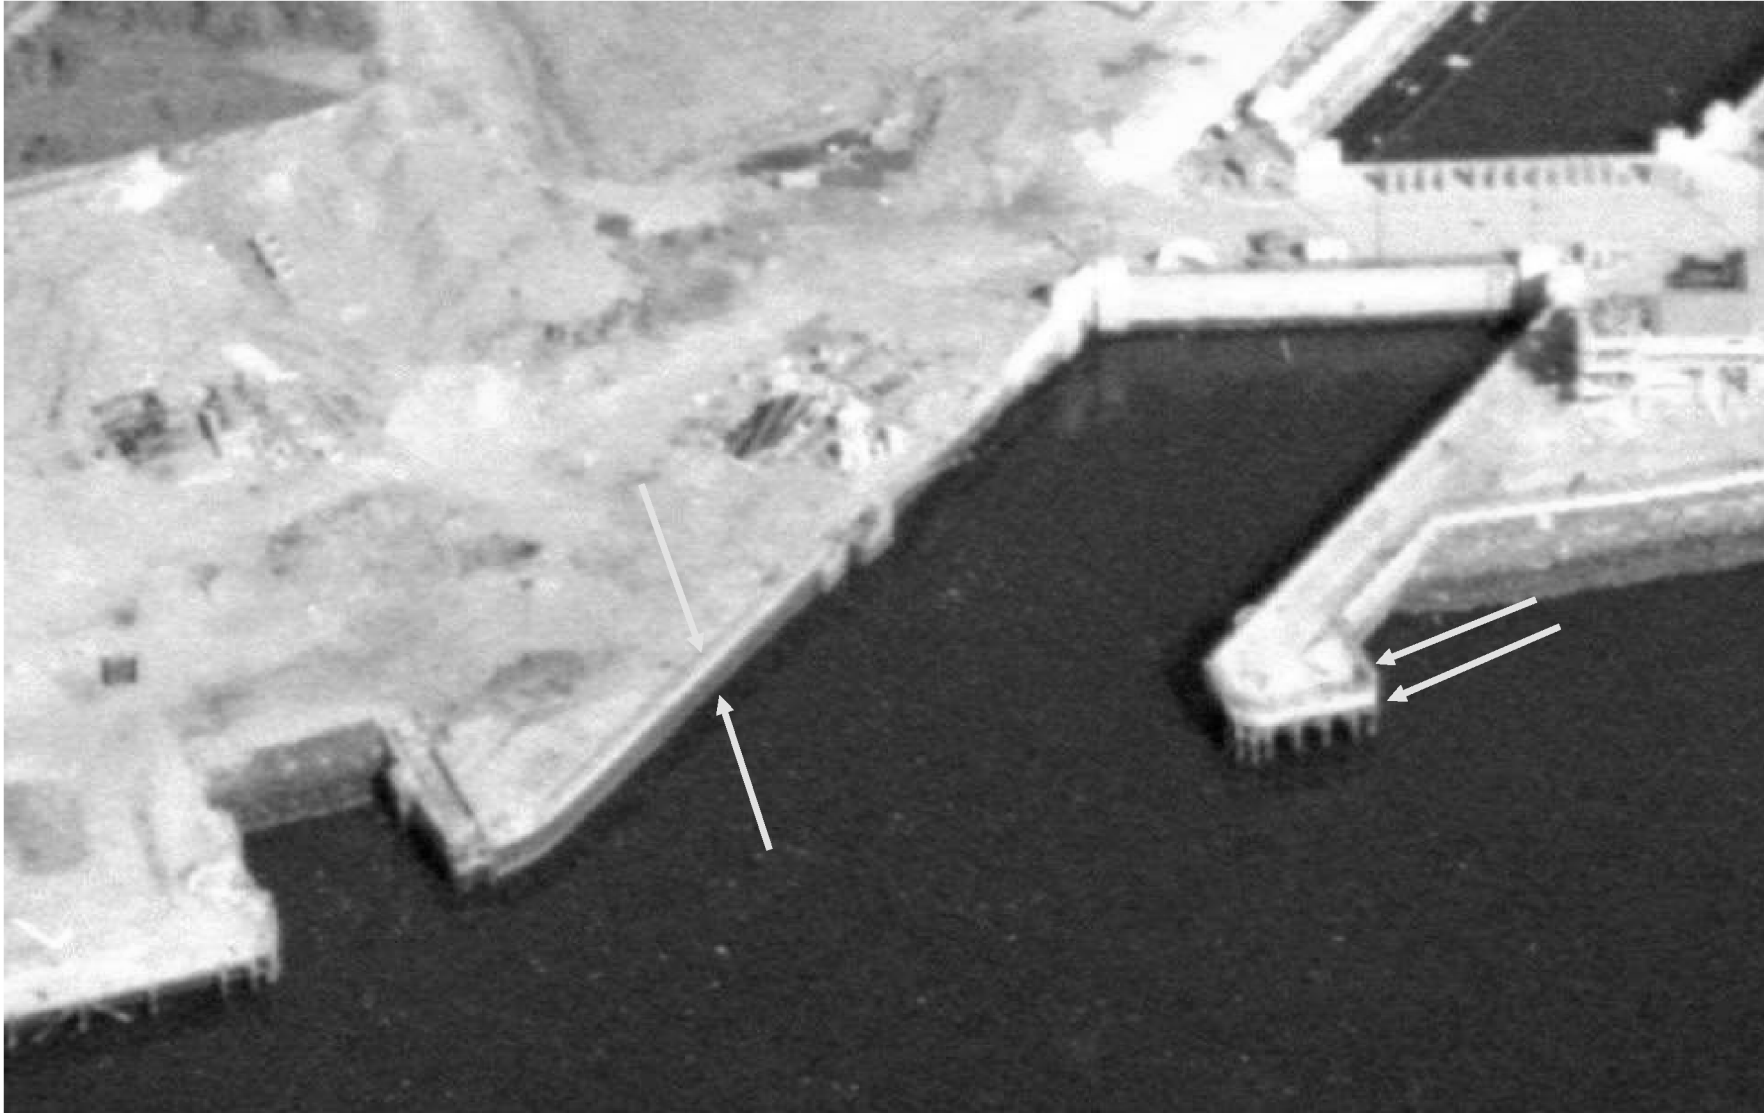
Item 3: 1998 showing the uplifted top layer of the site surface in progress of construction: visible in the section through the edge of the construction site

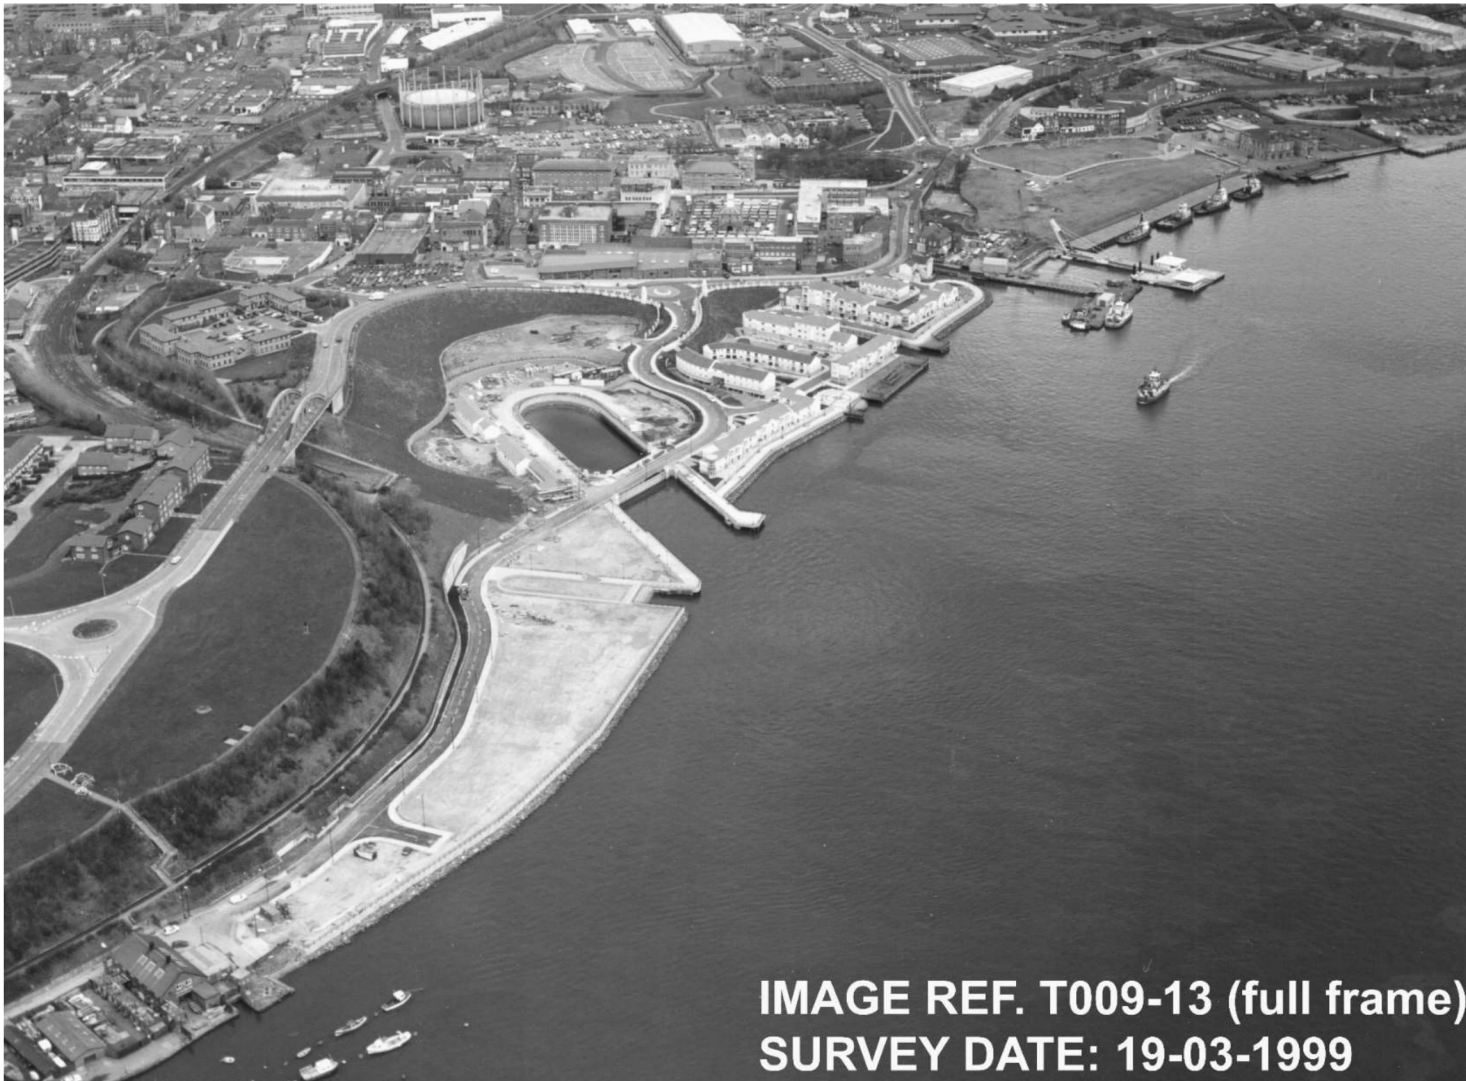
- The site was still not accessible for pedestrian use along the alleged route up until at the very earliest March 1999, but most likely some time after this date. This is proven by the dated aerial photograph, **Item 4**, which clearly indicates that the site was still a security-fenced construction area with open areas of construction materials, site structures such as cabins and substance containers, and open areas of construction materials, around which there was no safe or accessible area for public pedestrian use;

Item 4: 1999, site under active construction, surfaces laid, site structures, security fencing and containers in place. No public pedestrian access possible, as in 1996-8
